# **Heating and Electrical Systems Evaluation**

**Town of Gouldsboro - Town Hall and Fire Station #1**

**59 Main Street**

Walk-Through Survey performed June 4, 2026

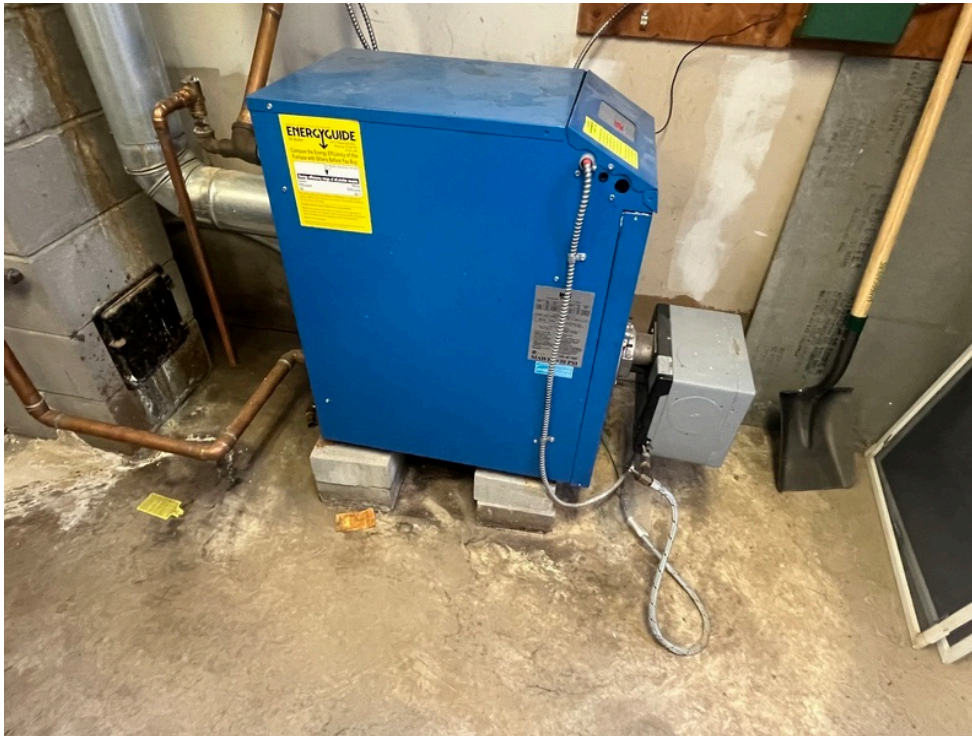
**Photo Number**  
**2**

**Description:**  
Heating boiler

| Cost Recommendation | EUL | EFF AGE | RUL | Year | Cost |
|---|---|---|---|---|---|
| Replace Oil-fired boiler | 25 | 16 | 9 | 9 | \$12,000 |

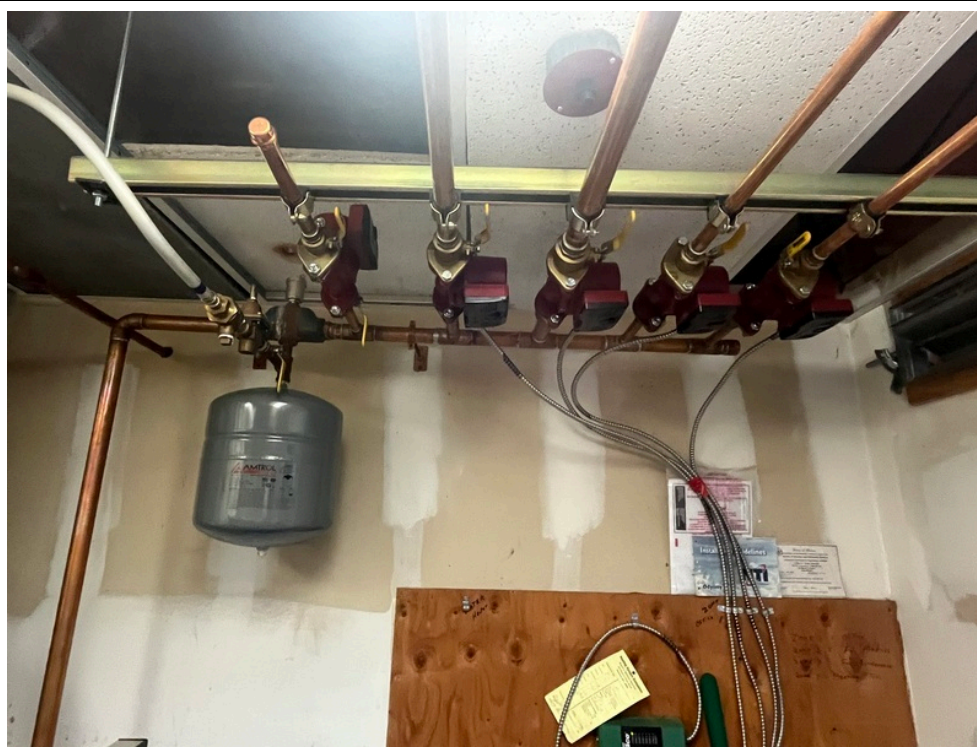
**Photo Number**  
**3**

**Description:**  
Heating circulator pumps

| Cost Recommendation | EUL | EFF AGE | RUL | Year | Cost |
|---|---|---|---|---|---|
| Replace circulating pump | 15 | 10 | 5 | 5<br>20 | \$2,250<br>\$2,250 |

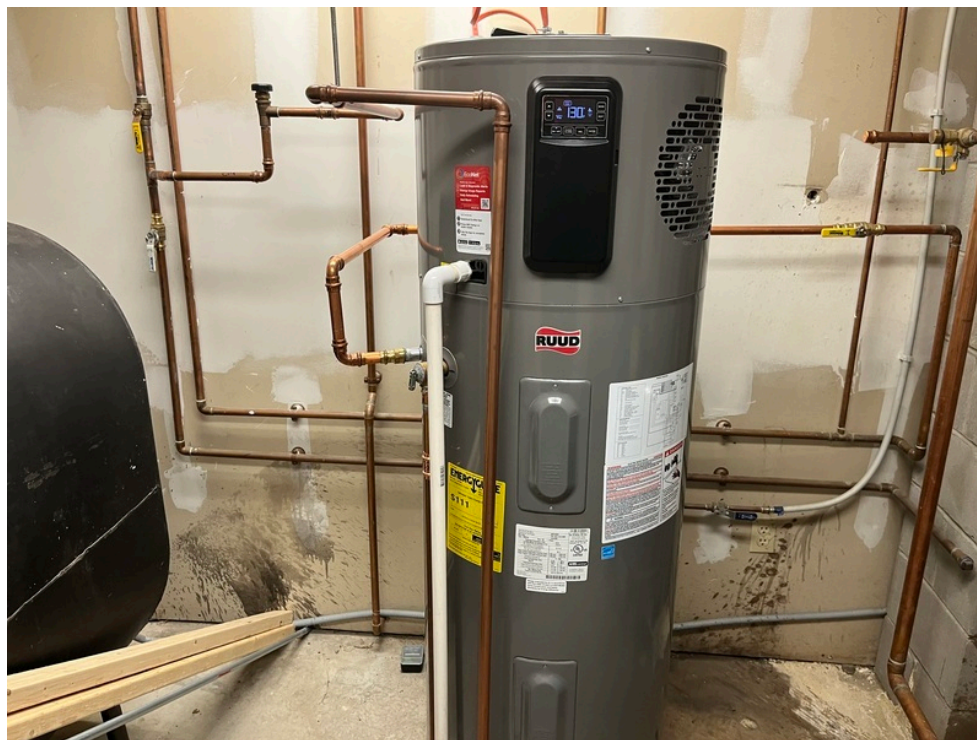
**Photo Number**  
**4**

**Description:**  
Domestic water heater

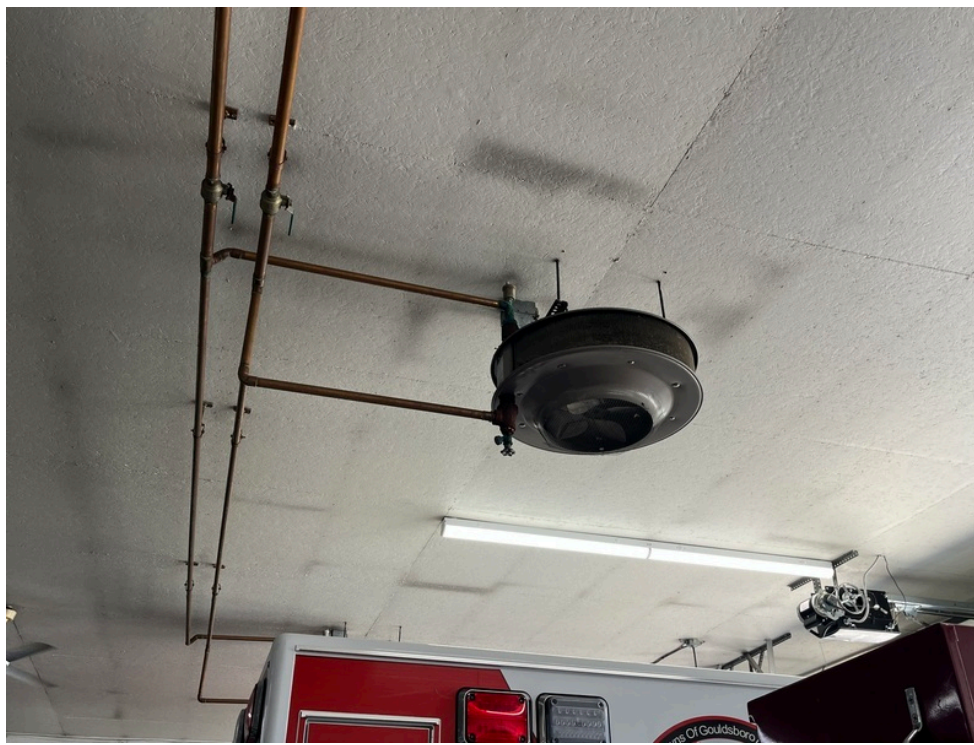
**Photo Number**

Hot water unit heater in  
Truck bay

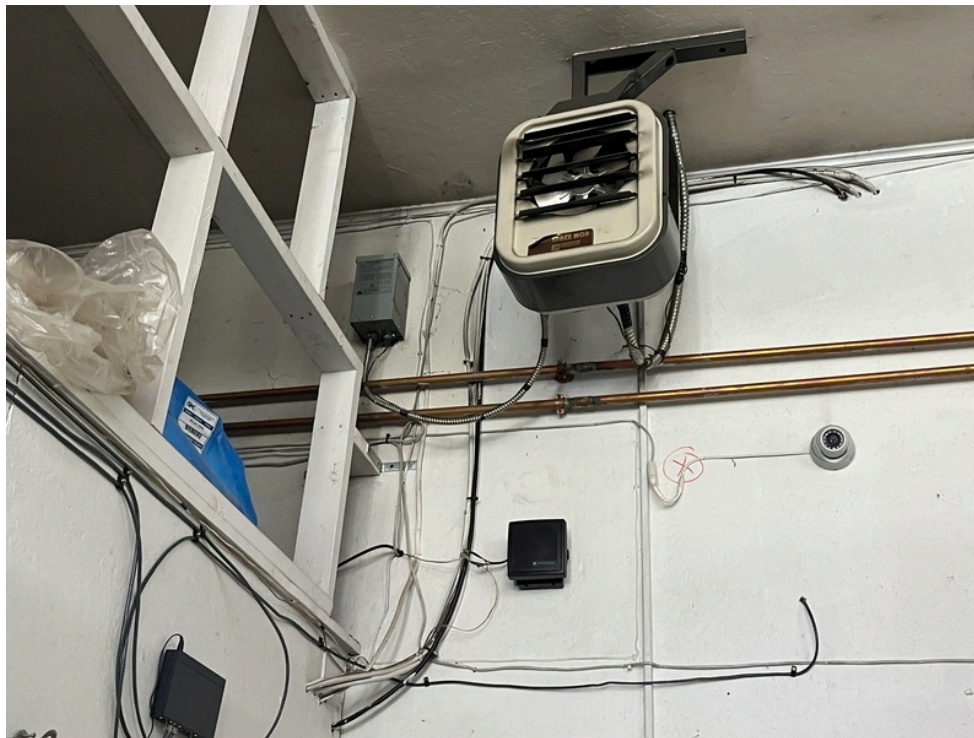
Electric unit heater in Truck  
Bay

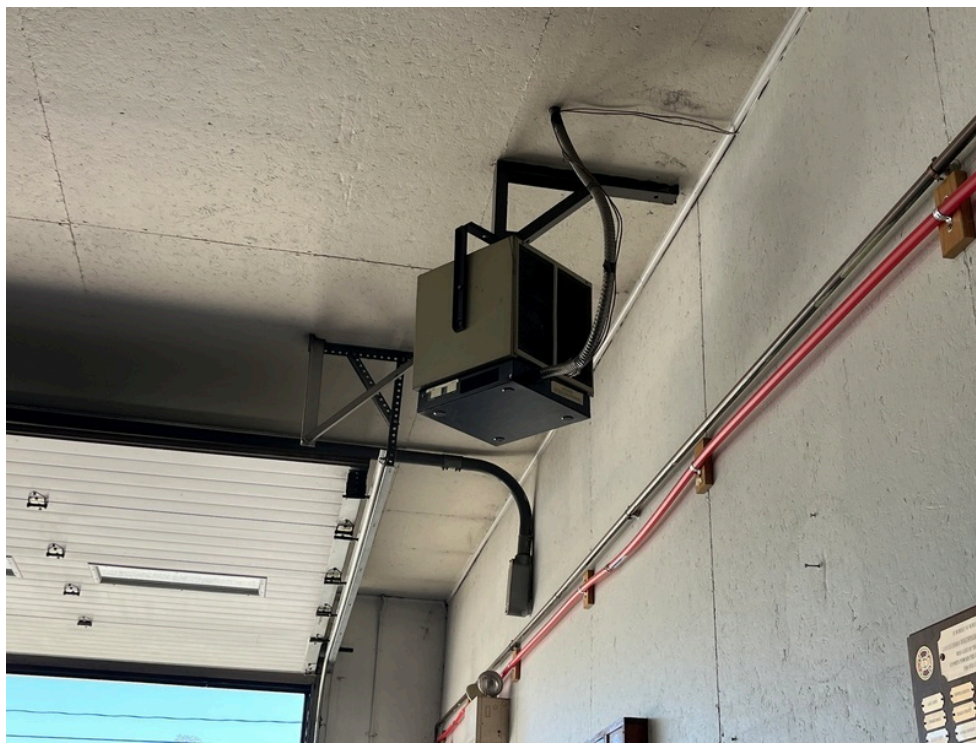
**Photo Number**  
**7**

**Description:**  
Electric unit heater in Truck  
Bay

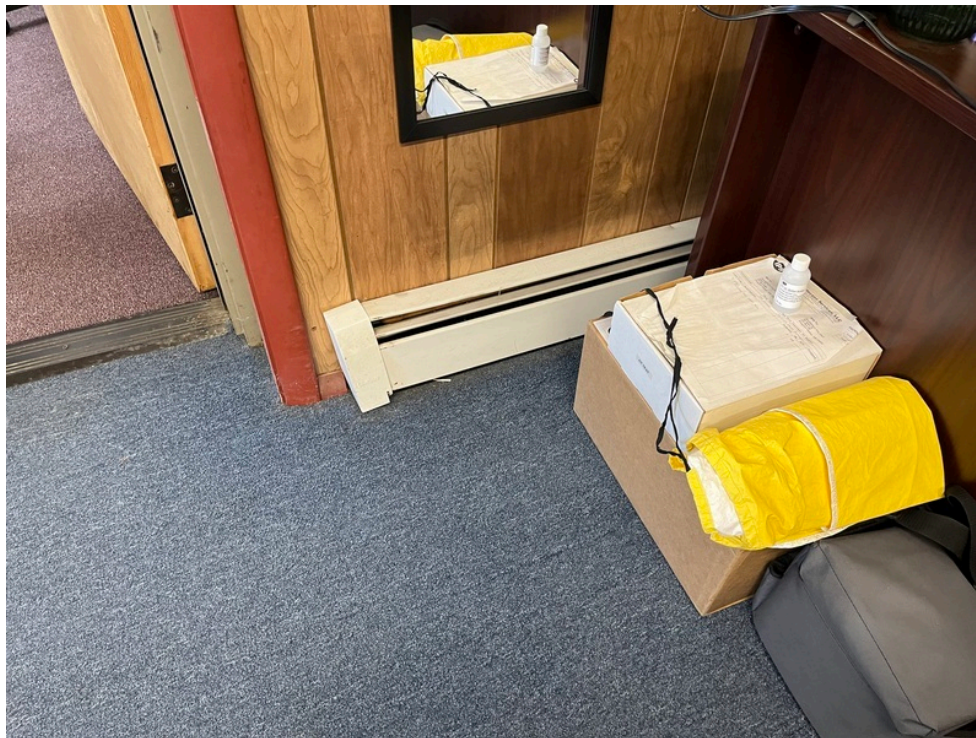
**Photo Number**  
**8**

**Description:**  
Typical baseboard unit

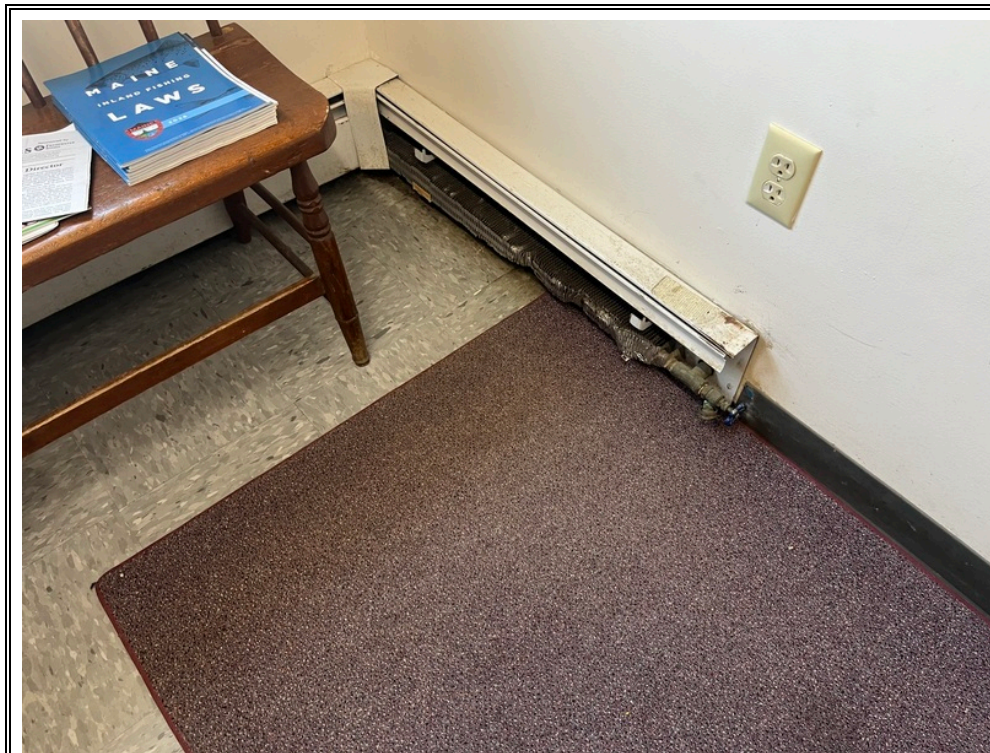
**Photo Number**  
**10**

2. There are 4 operating and one unconnected zone circulator pumps.
3. We noted damaged baseboard radiators in places, especially the main lobby.
4. There are 3 electric unit heaters in the truck bay along with two hot water unit heaters.
5. The distribution piping that we observed was un-insulated in many places above the suspended ceilings.
6. No source of combustion air for the boiler was noted.

**Description:**  
Damaged baseboard in  
lobby

| Cost Recommendation | EUL | EFF AGE | RUL | Year | Cost |
|---|---|---|---|---|---|
| Damaged baseboard repair/replacement | 25 | 25 | 0 | Short Term | \$1,500 |

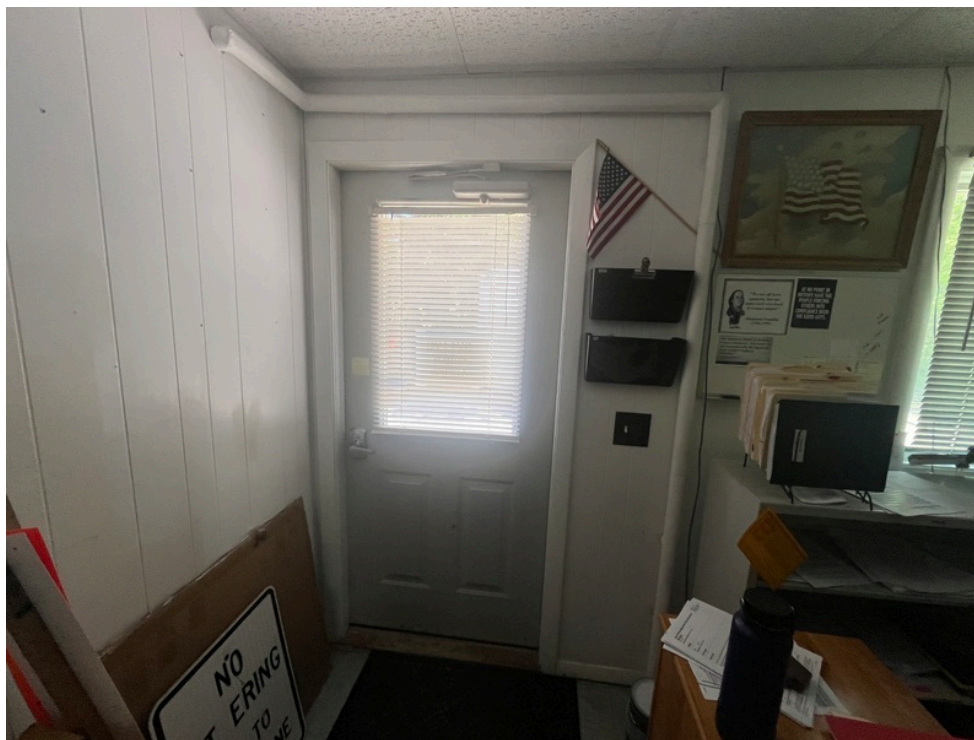
CEO office heating piping

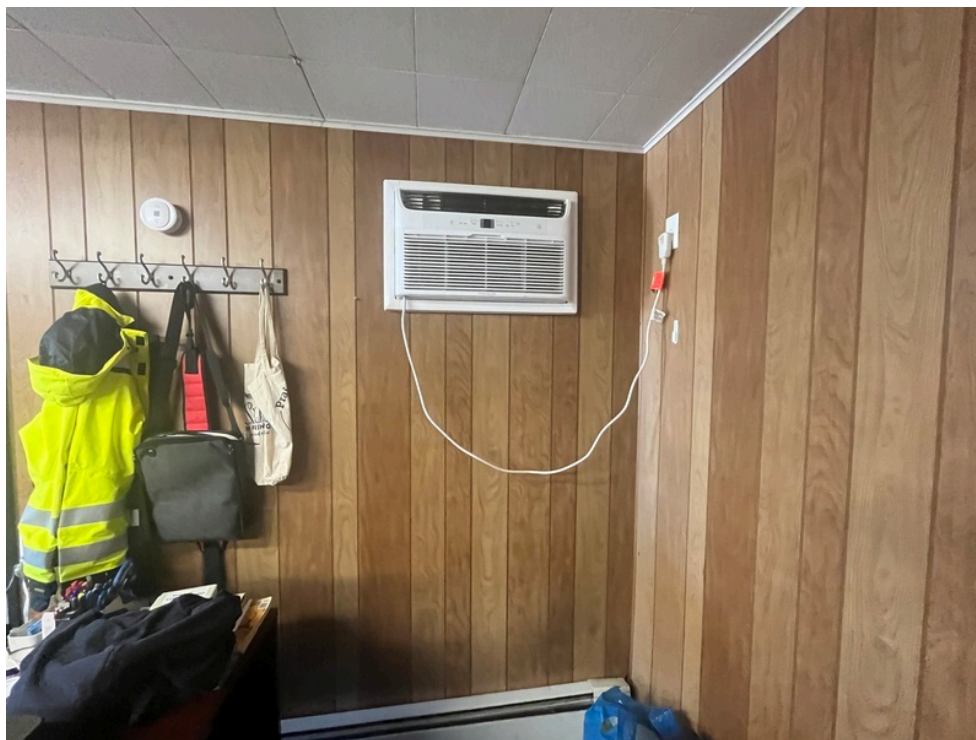
**Photo Number**  
**14**

**Description:**  
Wall AC in EMS office

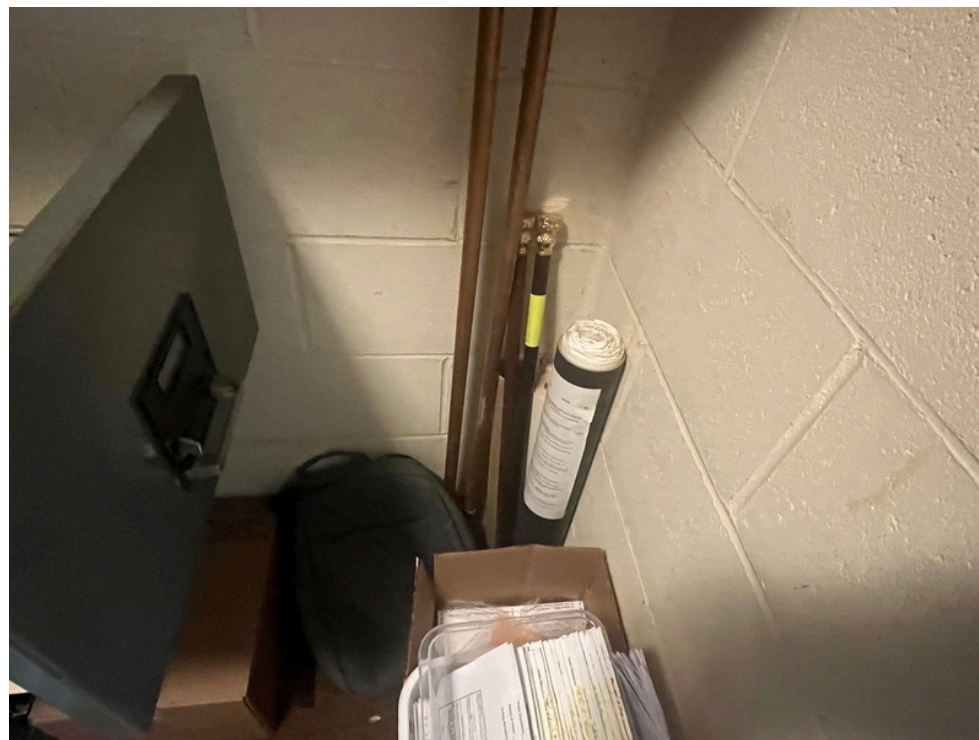
**Photo Number**  
**16**

**Description:**  
Heating piping in Mayor's  
Office closet

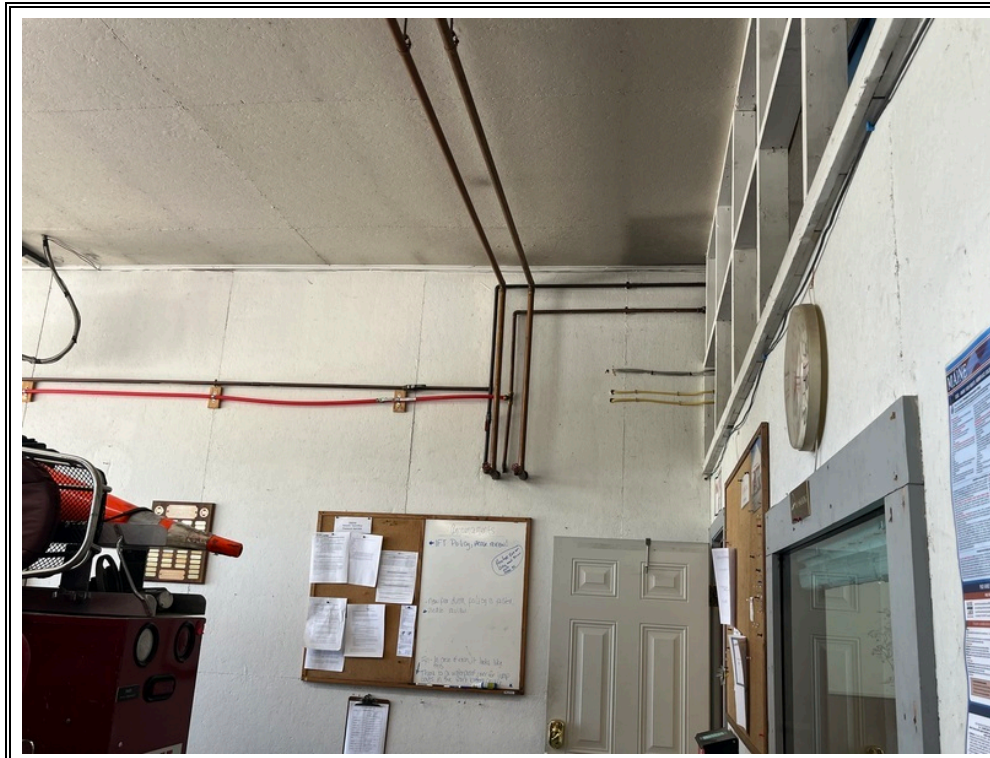
**Photo Number**  
**17**

Heating and domestic  
water piping in Truck Bay

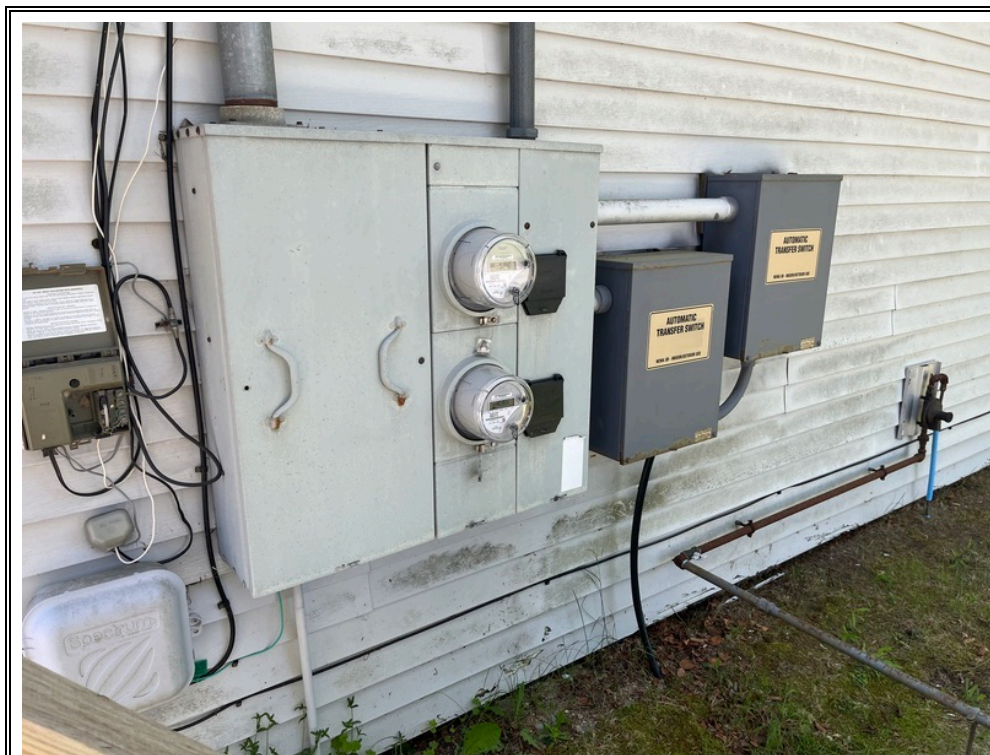
Electric meters, disconnects  
and automatic generator  
transfer switches

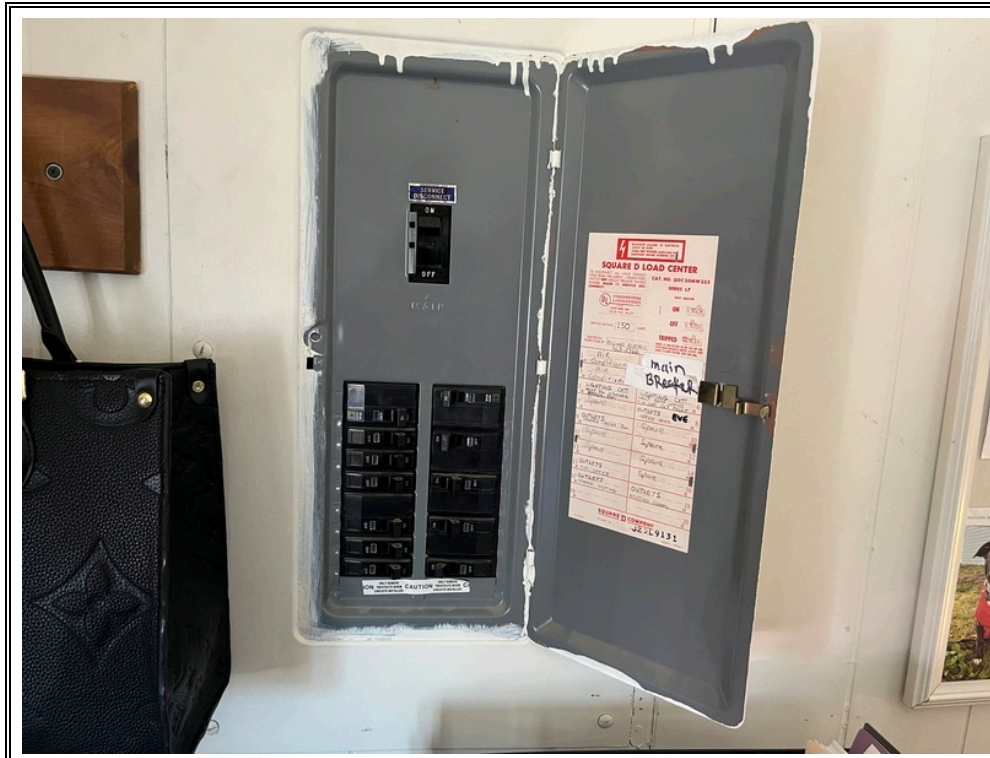
**Photo Number**  
**19**

**Description:**  
Electrical panel in Town  
Clerk's Office

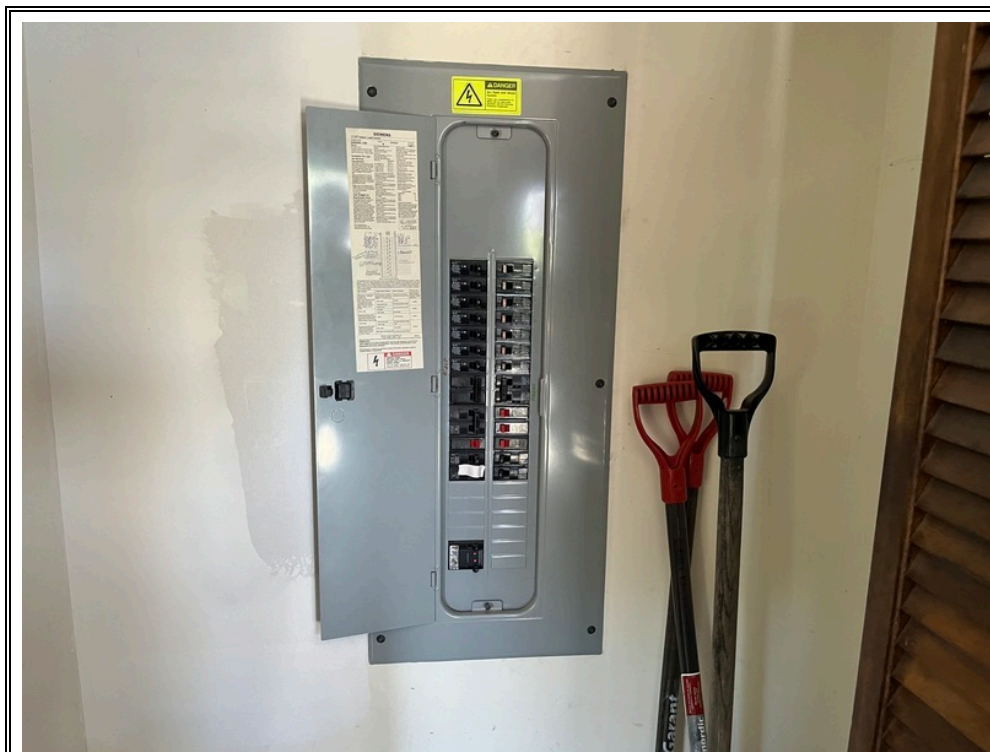
**Photo Number**  
**20**

**Description:**  
Electrical panel in Foyer  
closet

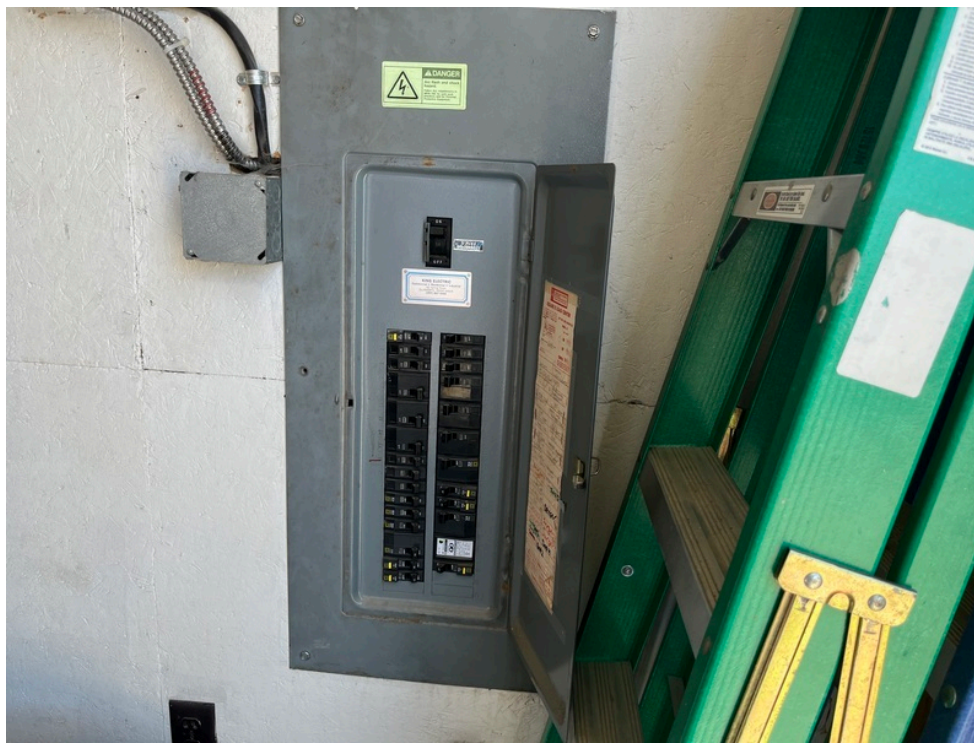
**Photo Number**  
**21**

**Description:**  
Electrical panel in Truck  
Bay

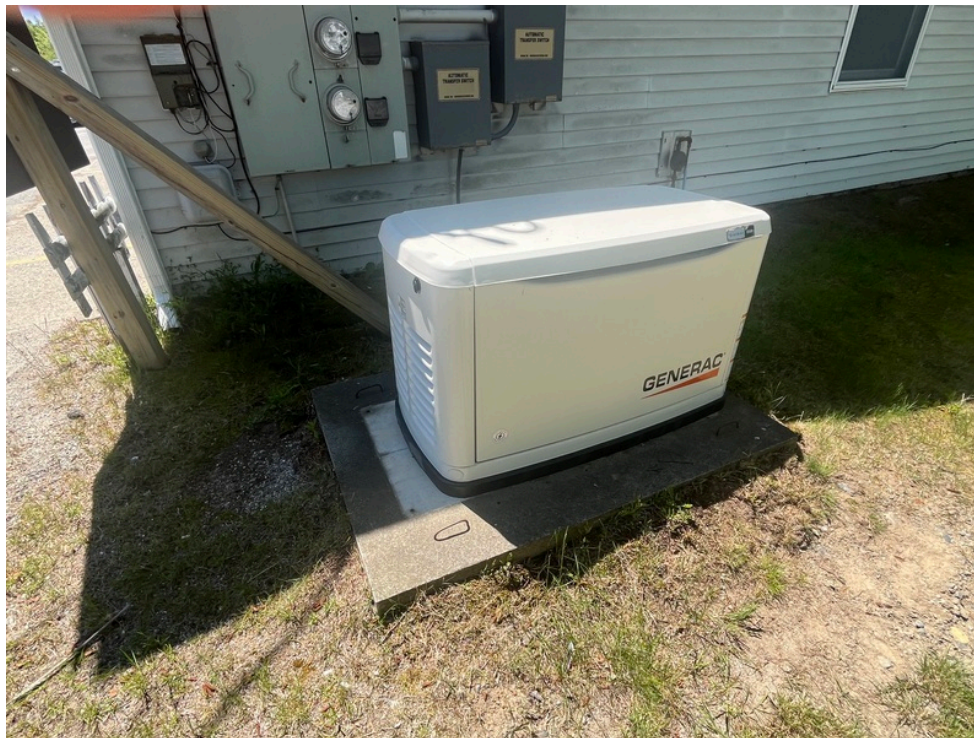
**Photo Number**  
**22**

No issues were reported with the generator capacity or function. The unit is less than 2 years old and is not expected to need replacement for at least the next 15 years with regular servicing and emergency operation.

**Description:**  
Propane Generator

| Cost Recommendation | EUL | EFF AGE | RUL | Year | Cost |
|---|---|---|---|---|---|
| Replace Propane Generator and transfer switches | 25 | 2 | 23 | 20 | \$25,000 |
